Case Study

Landuse Suitability and Infrastructure Assessment Gaza Province Mozambique

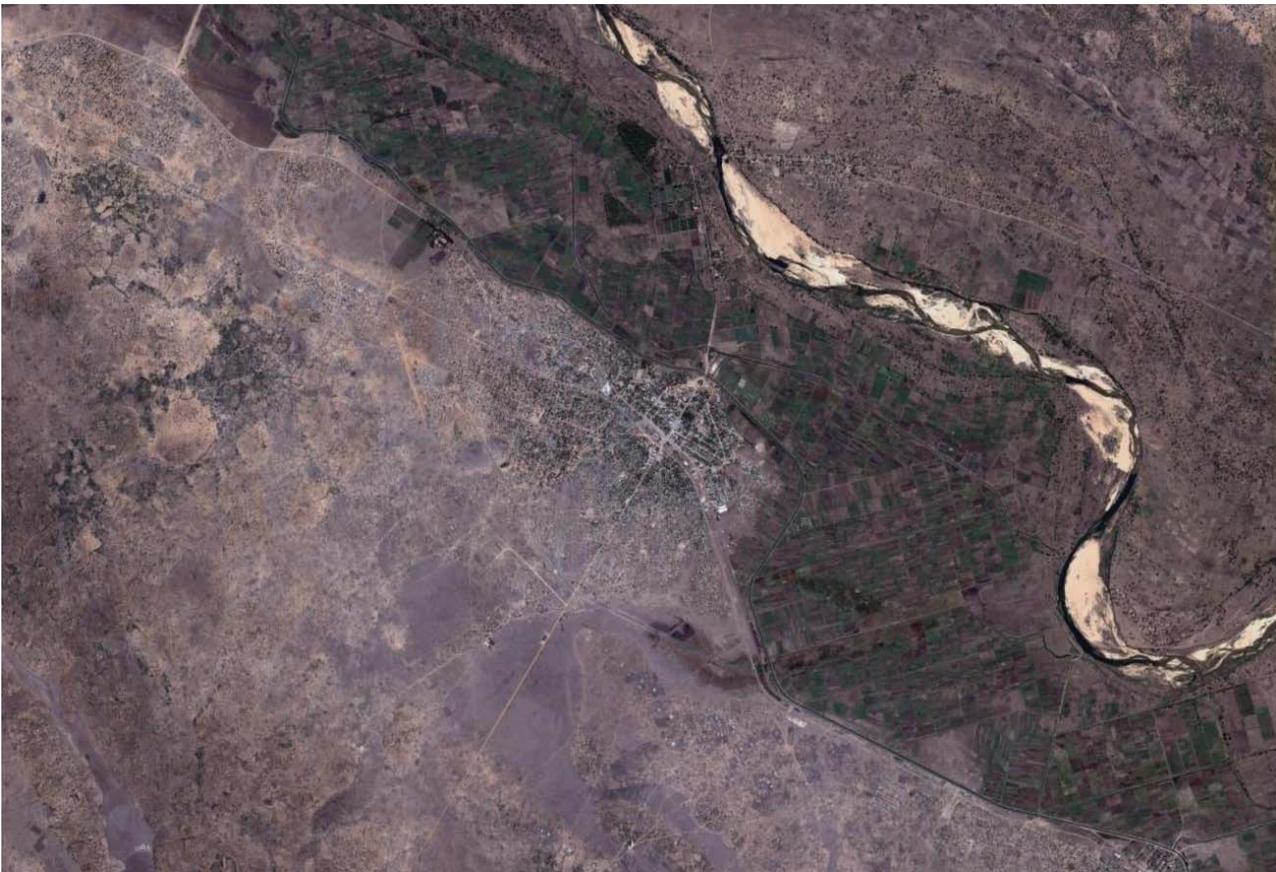
Fig.1 : Irrigation development - Gaza Province, Southern Mozambique

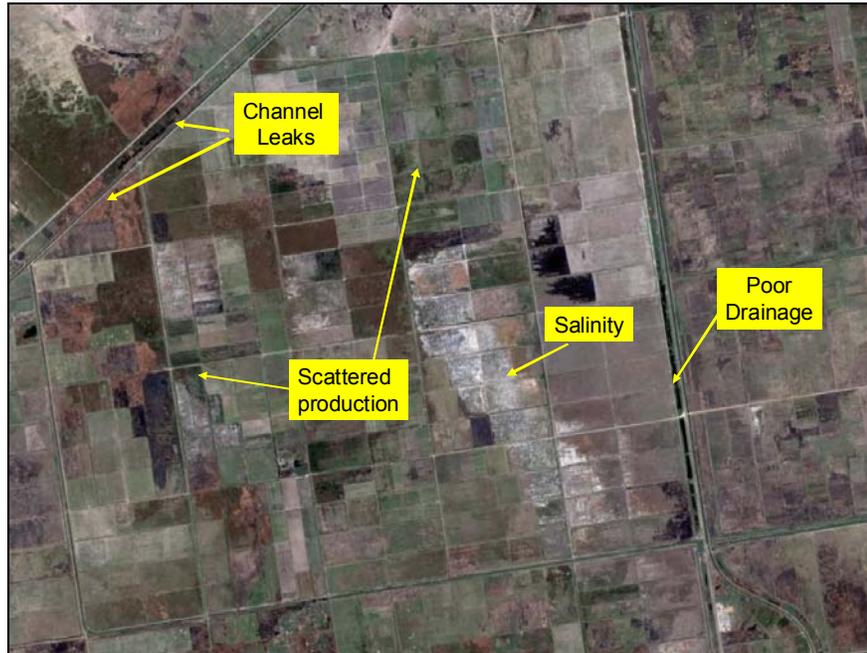
Initial investigations of available satellite imagery defined the geography of the study area, provided excellent background to the existing map and infrastructure information and highlighting a range of issues (fig 2-3.) not previously apparent to the client from 2 years of ground observations. These included;

- Large areas of apparent salinity
- Impact of poor channel management
- Isolated nature of existing production
- The extent of abandoned irrigated area

Fig.2 : Existing irrigation area management issues

1. Within the existing irrigation area, a large proportion of the land is marginally suitable to unsuitable for rice production because of elevated salinity. This land should not be irrigated unless remedial work is undertaken to lower salinity.

2. Existing salinity is likely to have been caused by previous and current irrigation system management in relation to fields, supply and drainage infrastructure. Cleaning of all channels to remove excessive weed growth and improved drainage water management is required to address the salinity issues.

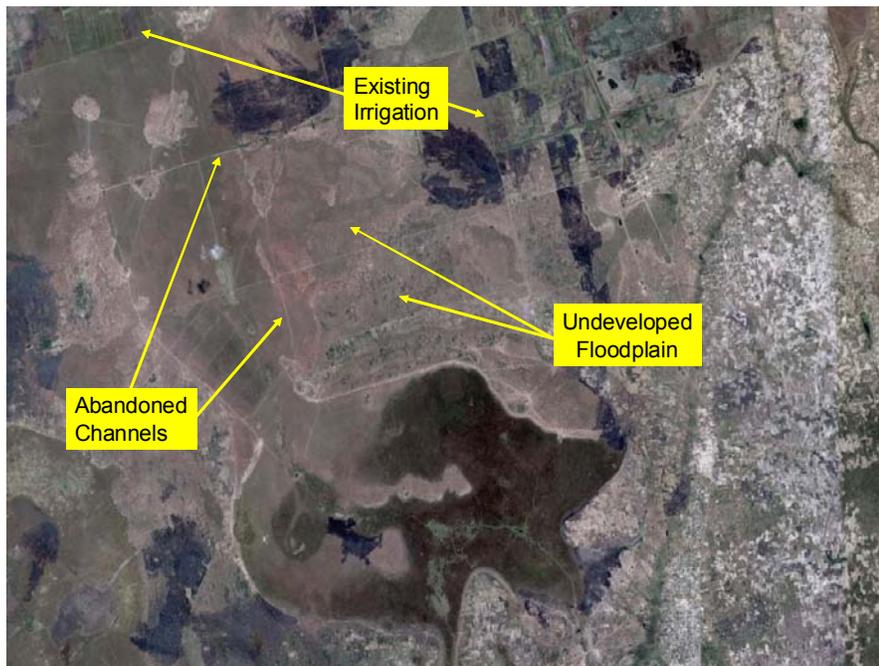
Fig.3 :Proposed irrigation development area issues.

3. Small areas in the proposed new development area are unsuitable for irrigation due to their raised elevation.
4. Small areas at the lowest locations of the undeveloped areas show potential for future development of saline conditions. These areas will require specific management strategies if they are to be developed.

5. The large majority of the proposed area is suitable for development and sustained rice production

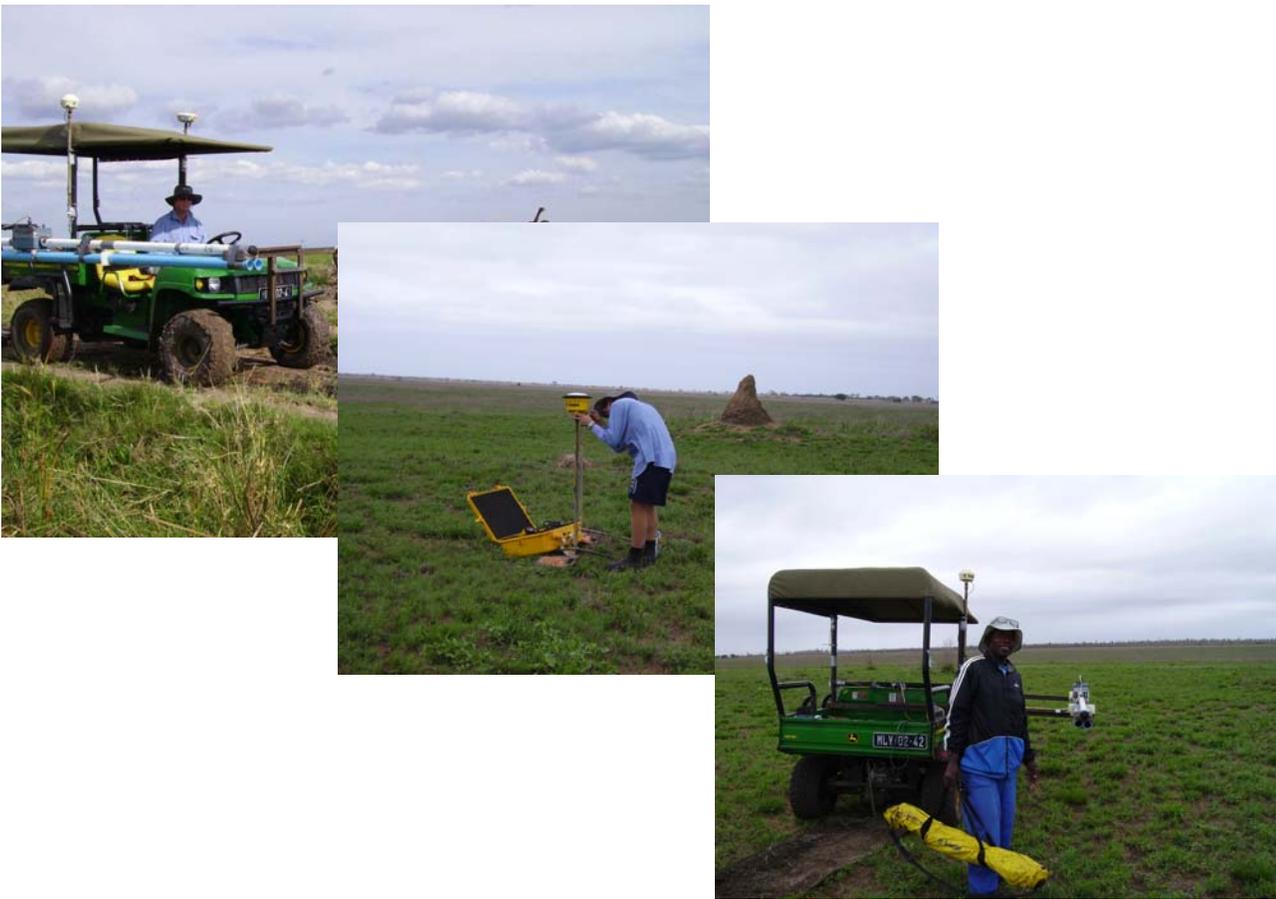
Following assessment of the satellite imagery and collated background information, a detailed soil conductivity and topographic survey was conducted using two electromagnetic induction instruments (Geonics EM31 and EM38) and high accuracy GPS equipment.

The instruments are mounted on a 4WD bike or vehicle (fig 4.) allowing access to all but the roughest and wettest land and measure soil characteristics to a depth of 6 metres.

Fig.4 : Electromagnetic induction instruments and RTK GPS mounted on a four wheeled bike

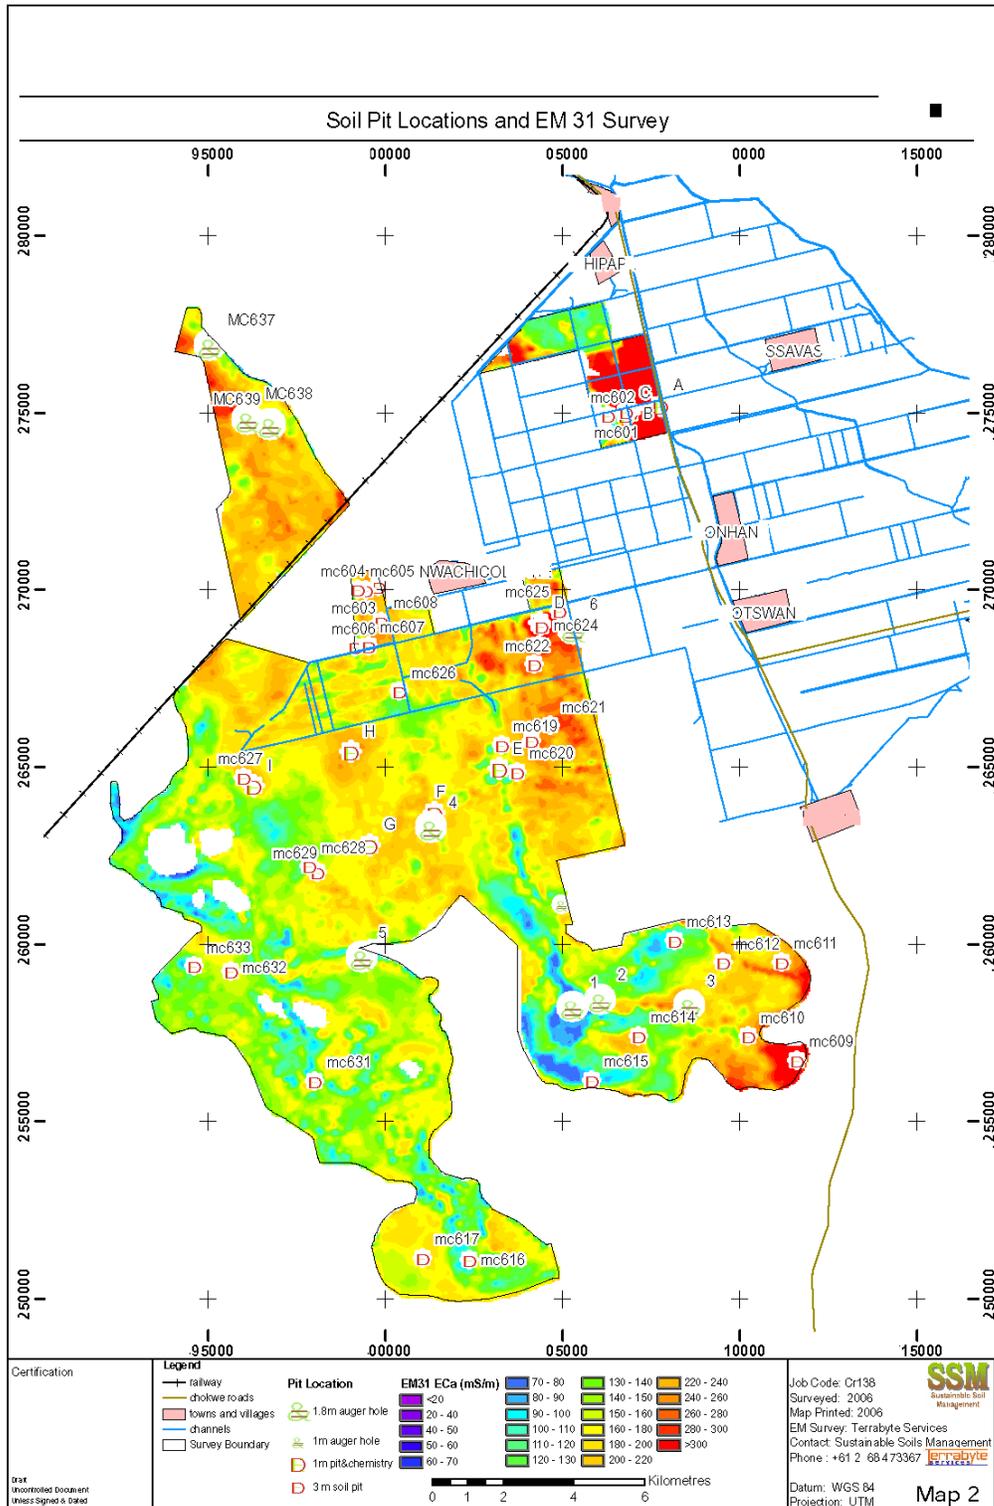
The EM survey data (fig 5.) showed a wide range of conductivity data with well defined trends across the survey area. The data clearly suggested that some areas were highly saline, some prone to develop salinity with the vast majority likely to be suitable for rice production. Utilising this information a targeted soil investigation and infrastructure assessment strategy was developed and implemented.

Fig.5 : 21,000 hectare survey area. Apparent conductivity and soil pit locations

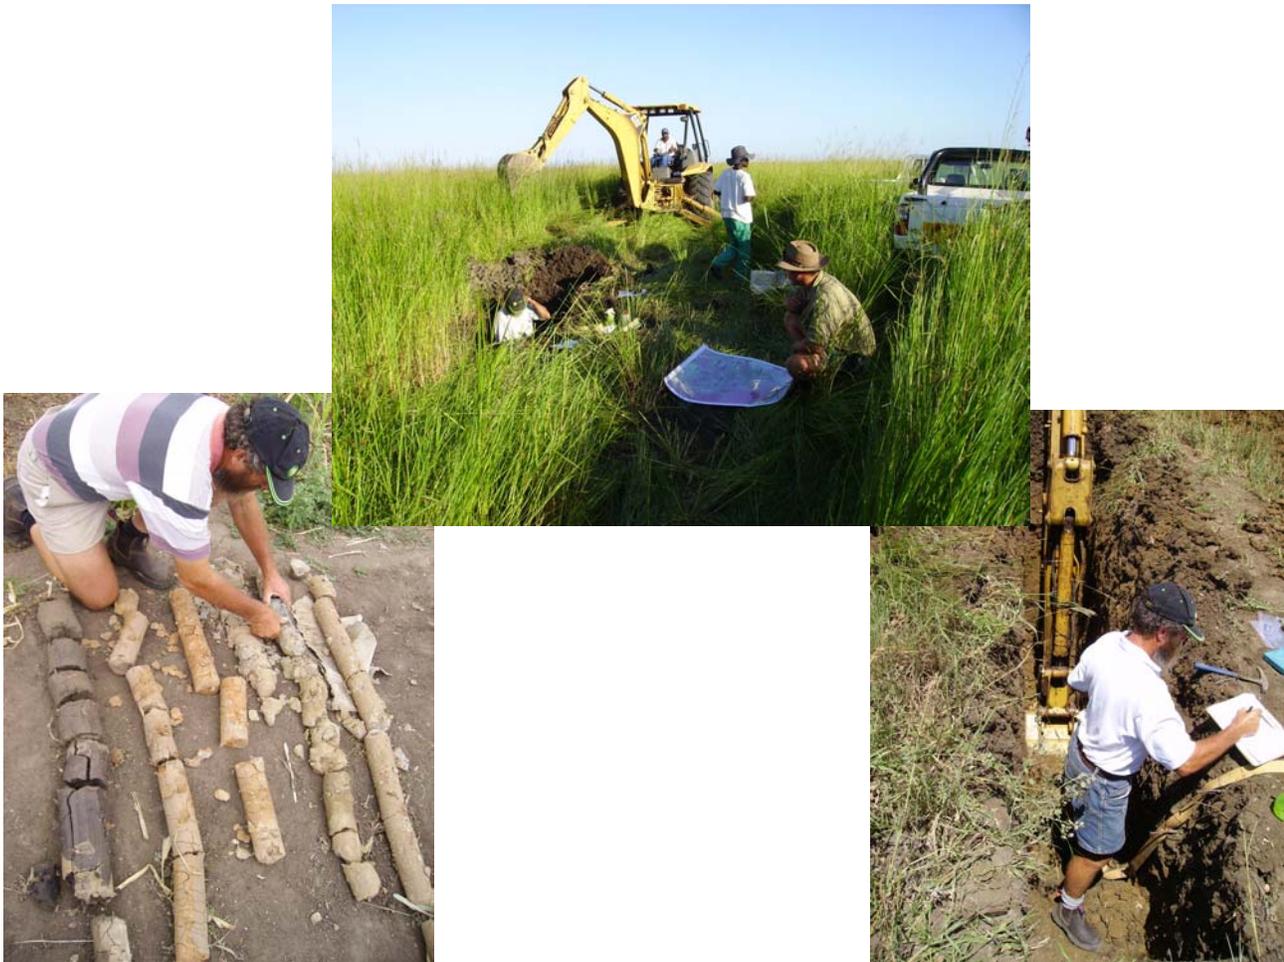
The targeted soil profile investigation plan was developed to initially determine the magnitude of difference between the highest, lowest and average conductivity locations, and correlate soil conditions and soil conductivity, from this further sampling is determined as required. Additionally, these investigations identified soil conditions at the time of surveying. Initial fieldwork (fig 6.) involved both physical soil description with samples retained for chemical assessment.

Fig.6 : Detailed soil investigations conducted at locations based on the apparent conductivity maps
